The Crash of Flight 143

Boeing 767 GLIDER

By Peter Banks

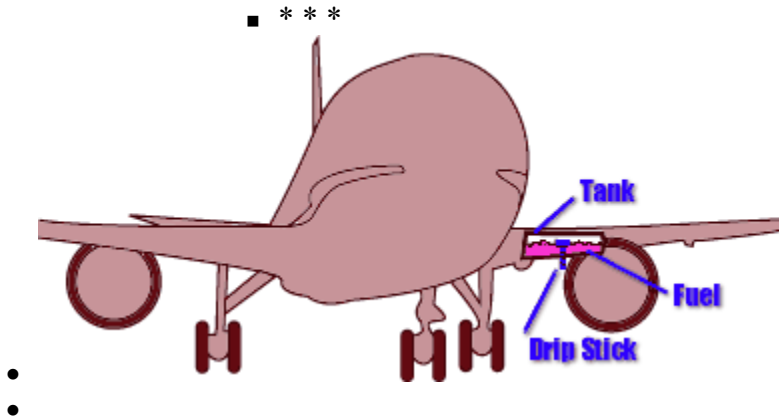
Before flight the drip stick is retracted into the wing and locked. When unlocked on the ground, the top of the stick floats on the surface of the fuel and the bottom drops below the wing and indicates the depth of the fuel. The mechanic also records the fuel temperature and the tilt angle of the aircraft if it is not parked on level ground. Tables in the aircraft handbook convert these readings to fuel volume.
